# POST-PROJECT ASSESSMENT OF PIT LATRINES IN RURAL PANAMA

A REPORT

In Environmental Engineering

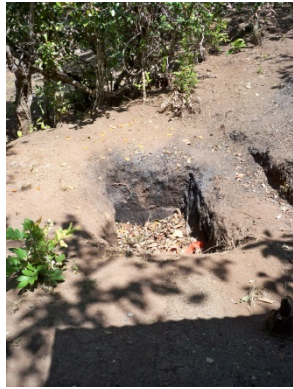
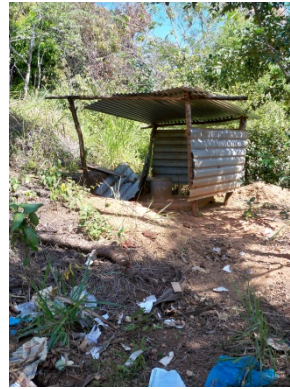
Figures: Typical waste disposal practices the author encountered during data collection: (A) A solid waste disposal pit, (B) Household typical of a score of "1".

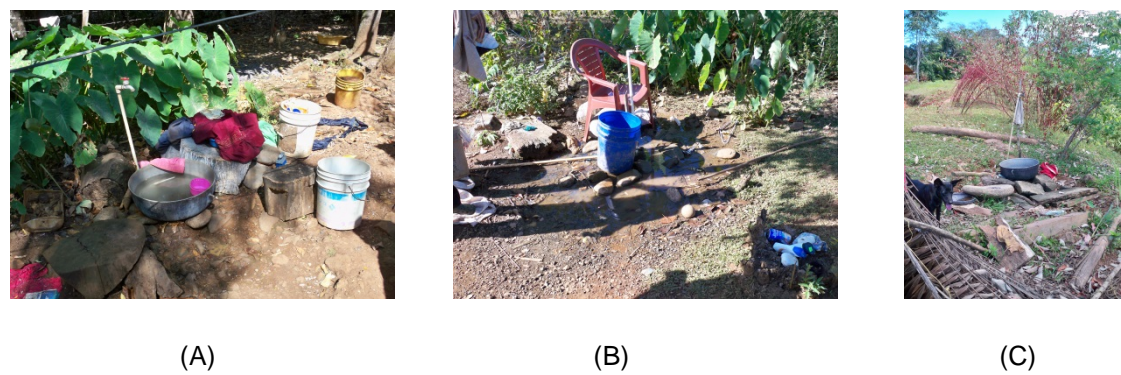
with high gradients for rapid runoff. It could be expected that this indicator would score lower in a different environment or season. Figure shows typical views of the areas around spigots.

Figure 7: Typical spigot connection to an aqueduct and wash area: (A), (B), and (C) are typical of washing area

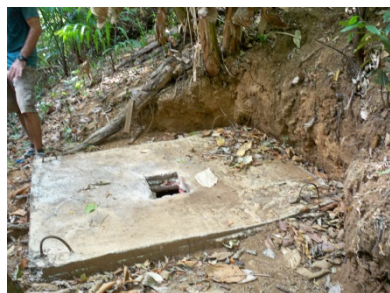
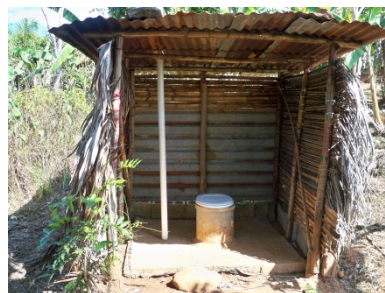
For this indicator the distribution of the scores indicated that if a cover was present, the hole was usually properly covered; however, nearly 50 percent of the latrines surveyed had no cover at all. Peace Corps does not provide materials for cover construction, or prefabricated toilet seats. Lids for 5 gallon buckets, or 2" X 12" scraps with handles were commonly observed as covers. Some of the latrines scored a 1 because the concrete seat structure was broken or never installed, and many of those latrines were abandoned or not in use. The EH sector does not provide a design or subsidy for a cover, meaning that the community members are required to find and pay for them on their own. Additionally, many of the covers are not attached to the seat, making it likely that children or unaware people will leave it off after use. The highest score was 2.57, in Vallecito, Cocle and the lowest score was 1.20, in Bajo Membrillo, Comarca Ngöbe-Bugle. Figures 11A, 11B, and 11C are indicative of scores "1", "2", and "3," respectively.

*Figure 11: Typical photo of latrine covering methods: (A) A score of "1", (B) A Score of "2", (C) A Score of "3".*

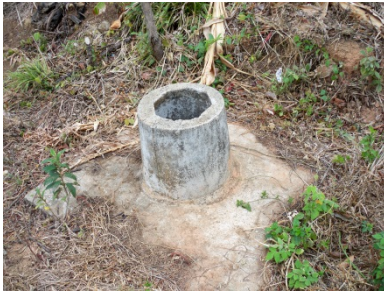
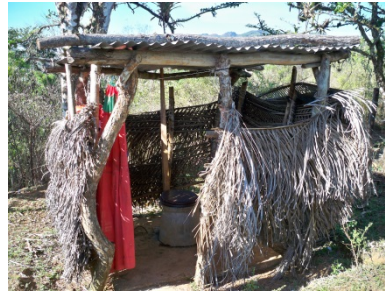
Figure 13: Typical view of privacy structure: (A) A score of “1”, (B) A score of “2”, (C) A score of “3”.

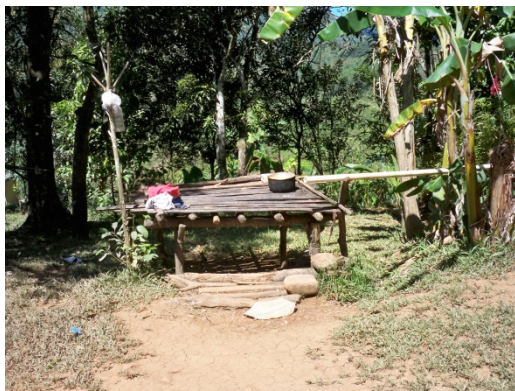
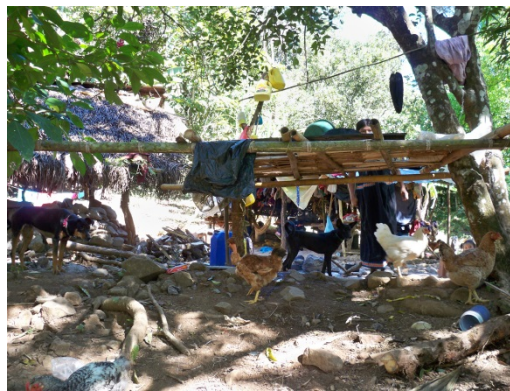
Figure 16: Typical view of Kitchen Areas: (A) A score of "2", (B) A score of "1".

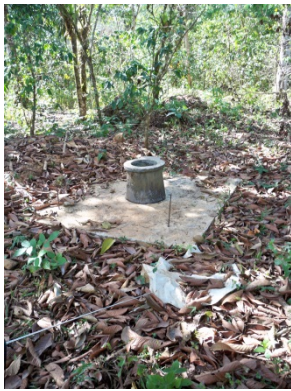
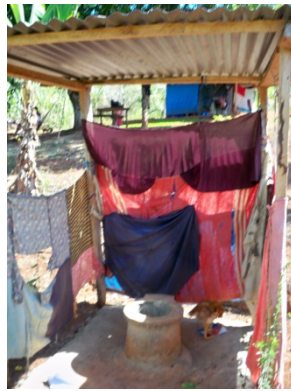
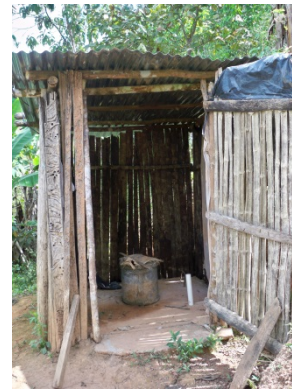
Figure 19: Typical Latrine Usage: (A) A score of “1”, (B) A score of “2”, (C) A score of “3”
